[New Technology for Slab Repairs

An interesting project has been undertaken at McMaster University's Hamilton Campus in Southern Ontario. The Ronald V. Joyce stadium, which seats over 5,000 fans for many different sporting events, also encompasses a large parking facility directly below the playing surface.

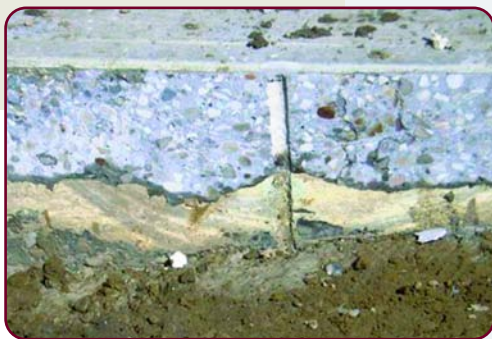
From small 5/8" holes drilled through the slab, the polymer resins are injected, delivering them to the underside of the slab to fill any existing voids, lock up loose base soil material and eliminate the rocking or movement of the parking facility slabs immediately.

From small 5/8" holes drilled through the slab, the polymer resins are injected, delivering them to the underside of the slab to fill any existing voids, lock up loose base soil material and eliminate the rocking or movement of the parking facility slabs immediately. The resins cure and harden to 95% of their compressive strength in 20 minutes, drastically reducing the down time and impact on the normal operations of this parking facility. McMaster University plans to proceed with the remainder of the parking garage area.
